Thule Air Base Airfield White Painting and Permafrost Investigation

Phases I–IV

June 2013

Final report

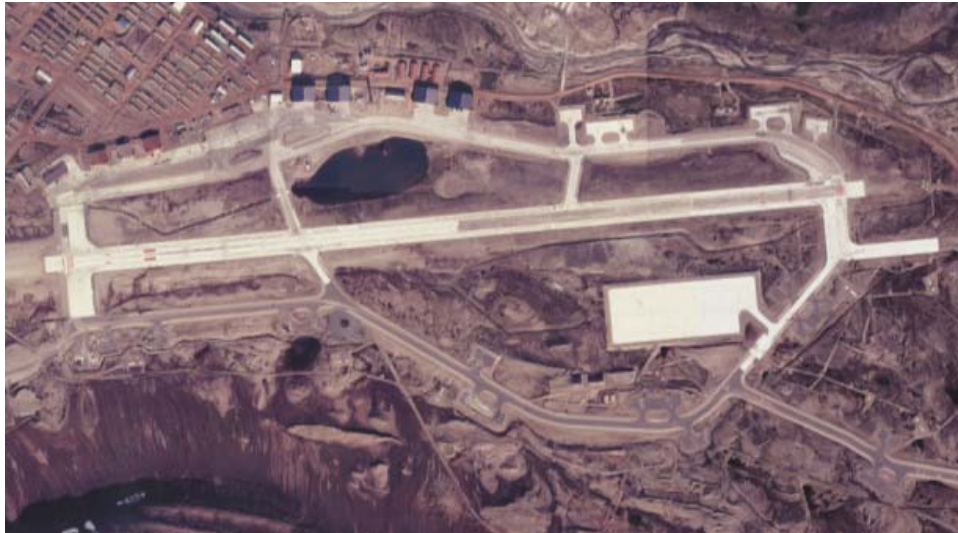
Figure 14. Undated photo of the airfield obtained from Thule personnel. The painting is in process during this photo. It is unknown if the dark pavement from approx. 50+00 to 100+00 is from wear or if milling or some other program is being conducted.

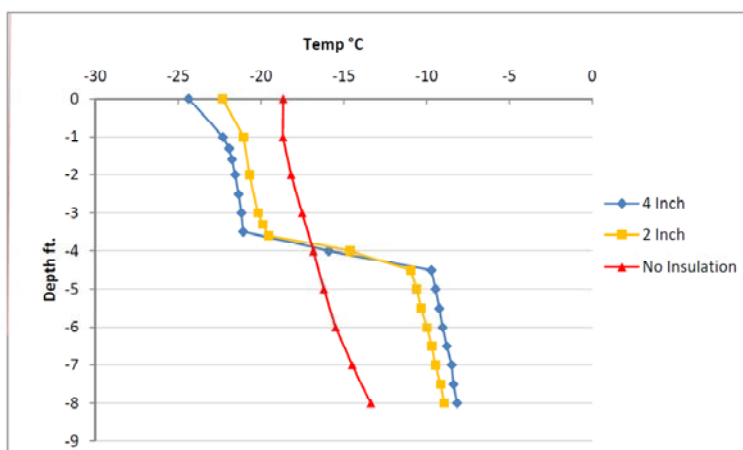
Figure 27. Insulation test measurement 1 April 2011. This plot demonstrates the thermal offset provided by 2- and 4-in. XPS insulation when the air is colder than the deeper subsurface.

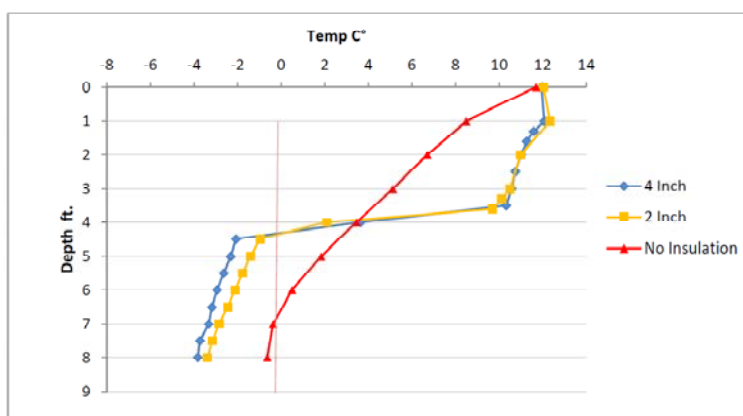
Figure 28. Insulation test measurement on 6 August 2011. This plot demonstrates the thermal offset provided by 2- and 4-in. XPS insulation when the air is warmer than the subsurface. The ultimate frost depth was held at the depth of the insulation. The summer of 2011 was the fourth warmest average air temperature recorded at the Air Base.

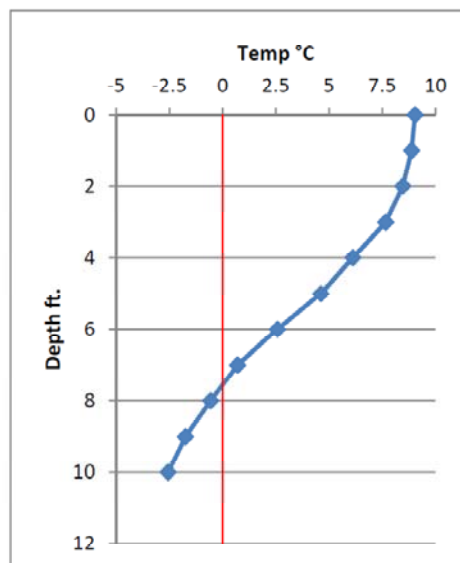
Figure 30. Subsurface temperatures measured at “Black Pavement” site. Measurement taken 11 August 2011 and is deepest thaw obtained for that summer, almost 7.5 ft, which is approximately 1 ft deeper than other measurements in natural colored pavement.

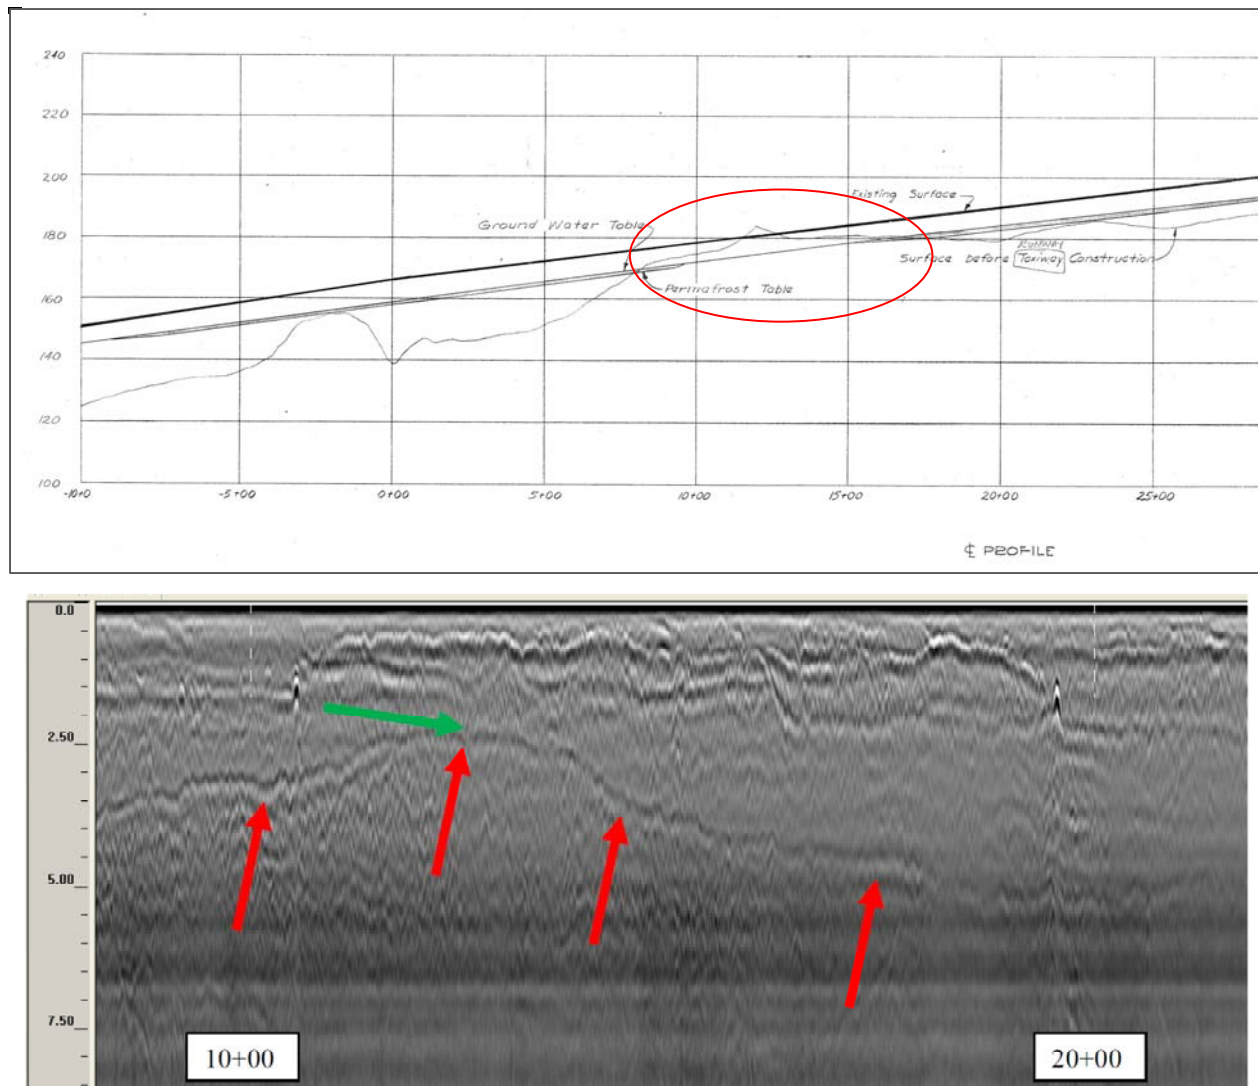
Figure 34. Top: a portion of the runway as-built provided by Metcalf & Eddy. A cut section is shown starting at 5+00 and ending at 17+00. The red oval indicates the location shown in the GPR image in the bottom figure, a portion of a radargram showing the subsurface between 8+00 and 22+00. Survey was taken on the right side of the runway between the centerline and the edge lighting. The rise in topography shown in top drawing is clearly seen at the red arrows. Green arrow indicates location where near surface ice-rich soil may exist at 8.2 ft depth.

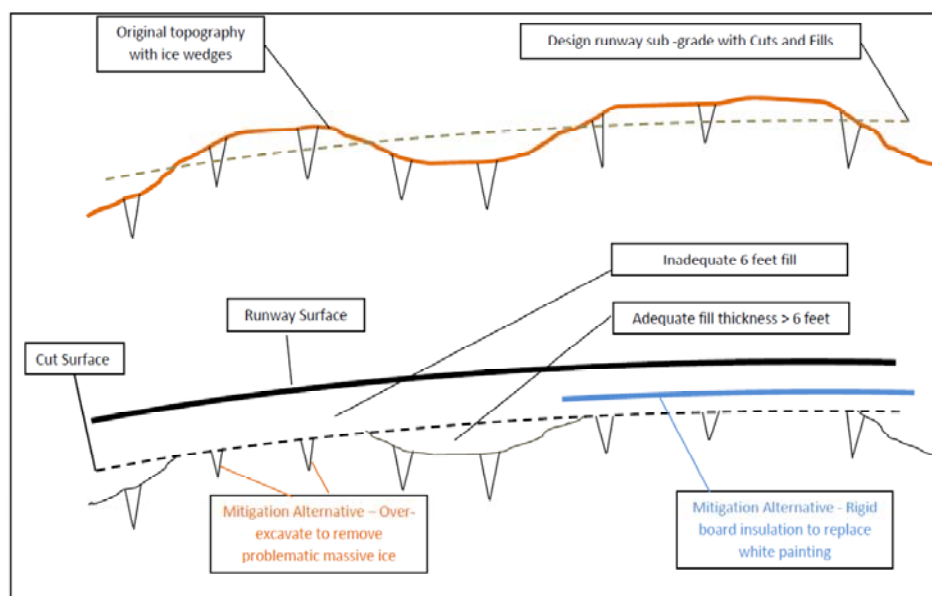
Figure 38. Thaw mitigation alternatives, over-excavation and insulation.

The effectiveness of installing XPS rigid board insulation at depth was discussed in section 4.5. The field test and computer thermal modeling demonstrated that this alternative will perform as required. Extruded polystyrene (XPS) is a closed cell material and will not be adversely affected by water. High compressive and flexural strength insulation, up to 100 psi and above, is available specifically for direct bury in a structural embankment. It has been shown to perform well under these conditions. A minimum installed thickness of 4 in. is adequate for the current climate and soil conditions, and will perform as needed if the mean annual air temperature (MAAT) increases by 2 to 3°C. For an anticipated climate change of up to 6 to 8°C, 6 in. of EXP will be required. Figure 38 illustrates the concept and installation of the XPS.

The insulation would be installed at the specified locations for thaw mitigation and at the depth of 4 ft below the finished subgrade. This depth is optimal for ensuring that subsurface groundwater does not flow at a shallower depth than it is now. It also eliminates the possible issues with differential heaving between the insulated section and the adjacent uninsulated sections. Preferably, 4- × 8-ft sheets would be used and each sheet must firmly abut the adjoining sheet. The following layers should be staggered to overlap the previous layer's joints by at least 1/3. Care must be taken with the size of the earth-moving equipment used to minimize fill material lift thickness so as to not shift or damage the XPS. The 4-ft-deep excavation for installing the insulation should not encounter massive ice.

However, if this were to happen, the opportunity should be taken to over-excavate the massive ice to the fullest extent possible to ensure problem areas are mitigated.

Removal of the massive ice in known areas can nearly eliminate the possibility of thaw degradation. Excavation of the subgrade soils to the bottom depth of the thaw critical interval, or 9 ft, would allow for visible identification of massive ice that then can be surgically removed to beyond the depth of the thaw critical interval. If over-excavation is prescribed for a localized area with known massive ice, the entire subgrade to the full depth of the excavation should be removed and replaced with clean, compacted fill material. The only known locations for shallow ice in the active runway are 58+00 to 64+00 (Table 2). Figure 38 also illustrates the concept of over-excavation.
